Value Addition through Casing Integrity Evaluation using Multi Finger Imaging Tool (MIT)-Case Studies of Assam Asset

Rakesh Saxena*, Anurag, S. Shankar & Dr. T. R. Varun, ONGC

Value Addition through Casing Integrity Evaluation using Multi Finger Imaging Tool (MIT)-Case Studies of Assam Asset in North Eastern India

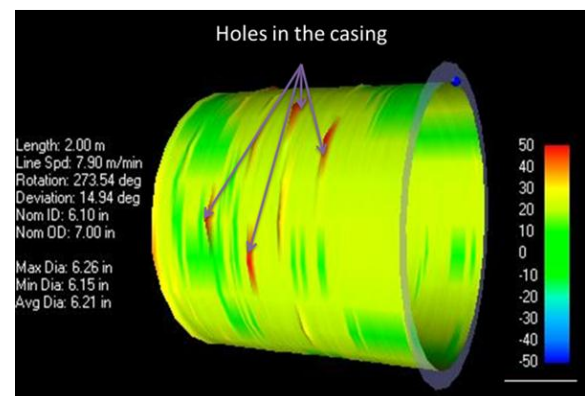
Figure II: Processed MIT Image of Well "A"

Tubings were subsequently pulled out of hole and well was handed over for casing inspection survey which was carried out in the interval X365.0 to X300.0m. On analysis of Multi-finger Inspection Tool logs(Figs.II & III), it was found there existed holes in the casing in the interval X361.5 – X363.5m., which was the main source of fluid loss in the well. Subsequently, CSQ was carried out in the interval X361.5 – X363.5m and finally well was completed in the interval X360.0–X363.0m as per plan. On activation, the well produced, QL - 10 m³/d, W/C - 60%, Q_o - 4 m³/d.

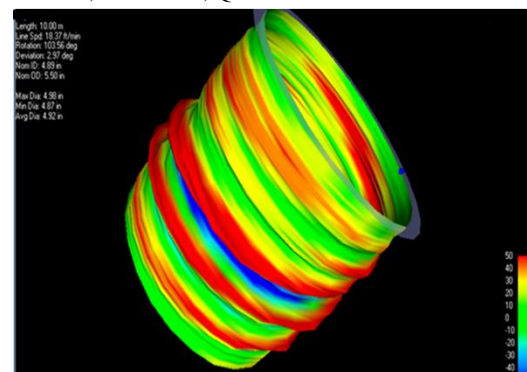
Figure IV: Processed MIT Image of Well “B”

It was concluded from PLT that perforated interval X682.0-X700.0m (TS-3A) was inactive and all the production was observed from squeezed perforations X496.0-X508.0m (TS-2).

Thus PLT also confirmed findings of MIT i.e. leakage / casing damage in the interval X500-X508m. Subsequently, damaged casing interval X500-X508m was isolated by keeping permanent packer at X600.0m and hydraulic packer at X432.0m. On activation, the well produced, QL- 52 m³/d, W/C- 92%, Qo - 4 m³/d.

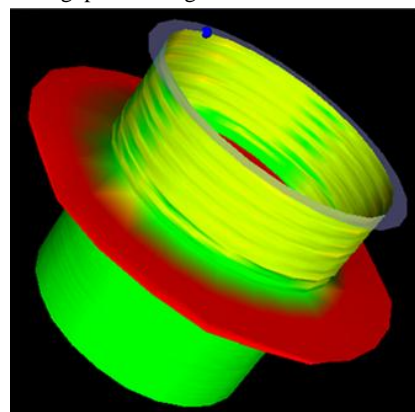
Figure VI: Processed MIT Image of Well “C”

was carried out but held up was observed at the same depth. Suspecting any damage / problem in casing, MIT was carried out in the interval X850m – X200m. Based on MIT log, it was found that Casing Collar slipped from X944.73 – X945.1m Figs.VI & VII. Subsequently, it was decided to suspend further workover operations looking the severity of casing damage, which can not be repaired with the present available resources. Rig was released to next location without any further delay. Thus, MIT survey could provide clue about the extent of casing damage/abnormality thereby saving precious rig time.
