Value Addition Using Cement Evaluation by Ultra Sonic Imaging Tool In Upper Assam Oil Fields

Narender Pal and M.M. Ahmed

Frontier Basins, ONGC, Dehradun

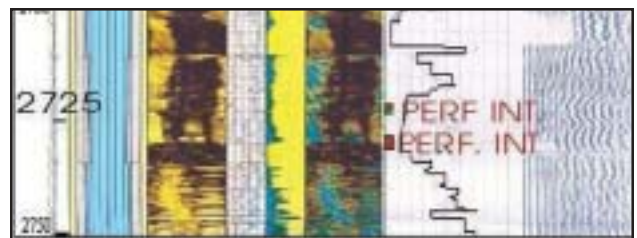
Fig. 1: USIT & CBL OF WELL NO. G—A.

WELL NO. G- A (fig-1)

Well was drilled as a development well with an objective to test Miocene prospects. After lowering final casing (5.5inch). CBL was recorded, CBL amplitude was varying between 18 mV to 60 mV indicating bad cement, USIT was run to check the cement integrity, As the CBL shows poor bond in the presence of liquid micro annulus. USIT microdebonding logic clearly distinguishes micro bonded cement from poor bond, and it was observed that the recommended zone was isolated from the water-bearing zone.

It was decided not to do a cement squeeze job and go ahead with the perforation plan and test the recommended zone after six months. Rate of liquid flow increased with 14% USIT helped in determining the nature of cement behind the casing in the object of interest. The perforated object flowed oil initially @ 95 cubic meters per day with 0.5 % water cut. Cost of well was recovered by six-month production.

By interpreting the USIT data it was decided not to go for cement squeeze. , Minimum nine rig days, cost of logging operations, secondary cement job were saved.

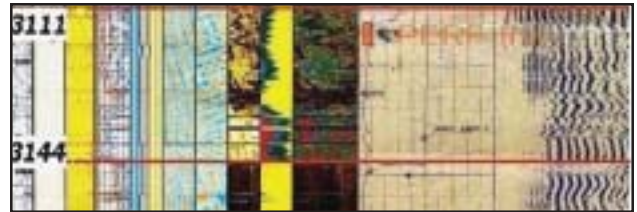
Fig. 4 : USIT & CBL of well No. R-D

WELL NO. R-D (fig-4)

Well was drilled as a development well for Miocene prospects and CBL was recorded after final casing (5.5 inch). Well data was reviewed along with CBL –VDL data. It showed satisfactory cement behind casing. So well was taken up for production testing. However well started producing water through perforation after some oil production. USIT was run to check the cement integrity behind the casing. It showed contaminated channel in the interval 3111-3114m. Cement repair job was done in the interval 3125.5-3126.5 m. and the same object was tested. Well-started producing oil @ 40 cubic meter per day with 0.6% water cut. USIT was able to determine the reason for production and hence remedial action could be taken which enhanced oil production
